## Royal Melbourne Yacht Squadron

# Interim Incident Report on the Nolex 25 *SERIOUSLY* on Wednesday 7 December 2022

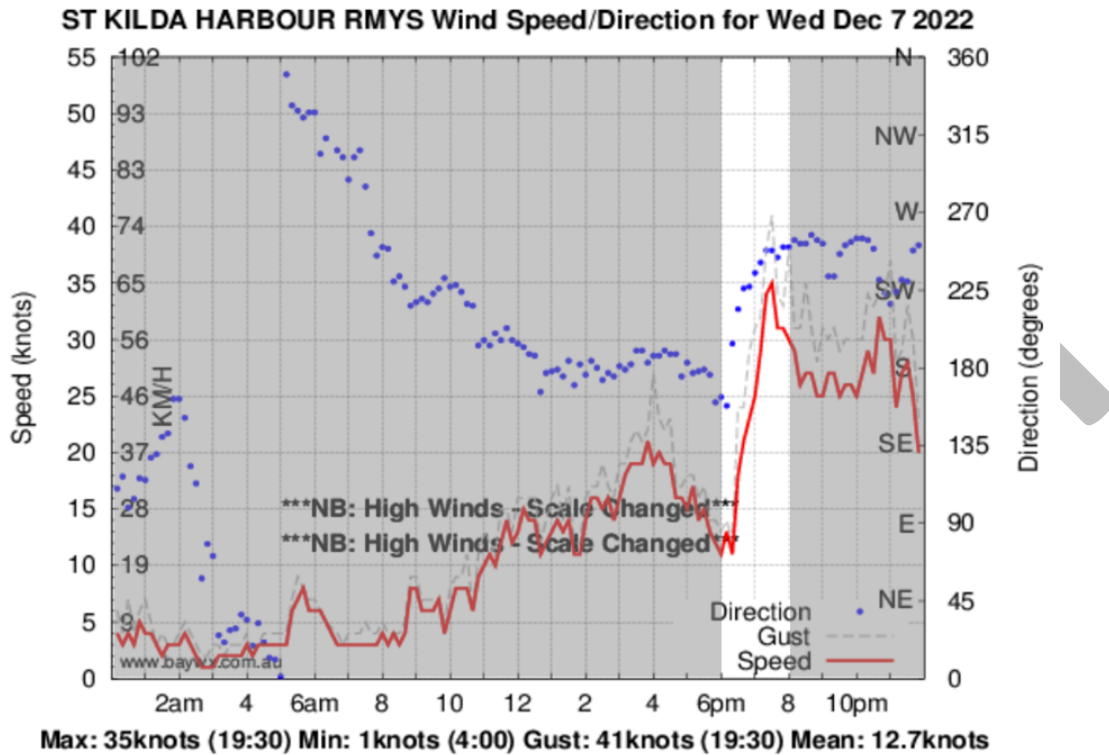
The winds recorded by the BOM at the RMYS tower were as shown in the following graph.

The wind strength was hovering around 15kts in the decision-making period leading up to the start. At the first start and through most of the start sequence it was around 11-12kts.

The average wind strength built over the course of the race and peaked at 35 kts average (41kt gust) around the time of the first finishers. It remained above 30kts for the full finishing sequence.

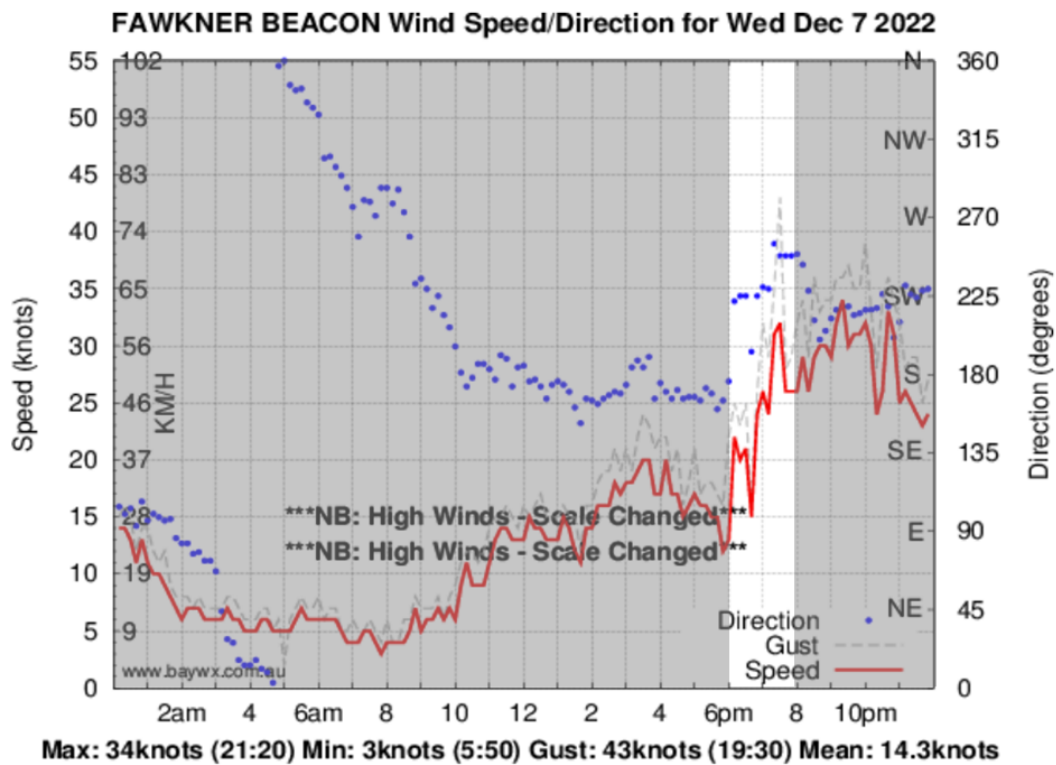
The winds recorded by the BOM at Fawkner Beacon were similar as shown in the following graph. The peak 10 min averages were slightly lower (by about 3kts) but the peaks were roughly the same.

**Note:** Wind readings from the instruments in the tower were around 5kts lower than those reported by the BOM from virtually the same location.

4. replace the tower anemometer (it is not possible to calibrate).
5. Update the SOPs
  - a. If equipment is not fully functional (eg. anemometer, lightbox, missing mark, etc) then this needs to be included on an alert sheet to the RO & RMT before every race.
